# TECH TIPS

DECEMBER 2002

c.p. Allstar Corporation, 443 Boot Road, Downingtown, PA

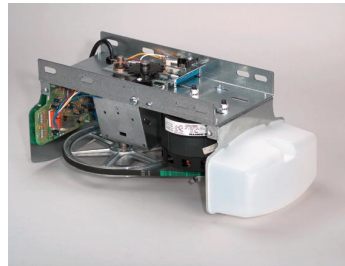
### BEFORE REPLACING THE BOARD

Check the diagnostic LED on the back of the operator. They are a great source of information. They will indicate photo-beam obstructions, contact reversals and shorted pushbutton wires. Below we have listed a few additional helpful hints.

Disconnect all of the wires from the terminals on the back panel. You will be able to run the operator using a jumper from terminals 1 and 0. When the photo-beams are disconnected, you will be able to close the door with constant pressure. Attach one device at a time and test before connecting another device.

Did you know that the back panel of the MVP can be swung out by loosening the back panel screw on the left side of the operator (looking towards the door). This makes changing boards much easier.
